1967 Kombi Restoration : Part 2

Metal Work

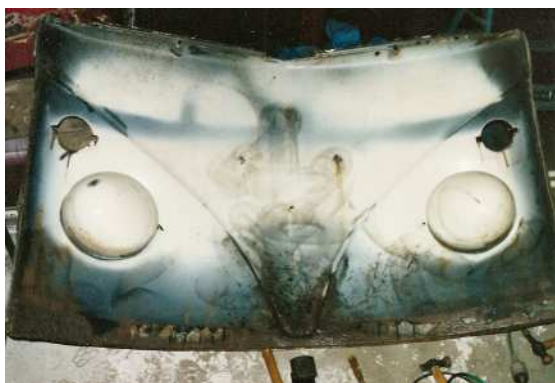
In June 2001, my attention turned to the kombi's nose. With plenty of trepidation I unpicked all the welds around the side and bottom. Then I simply cut across the bottom of the windscreen: because the lower sections had to be replaced I had plenty of room to move and this left me with clean metal at the top of the nose to graft to. Likewise with the valence, as it was being replaced it could simply be cut away. The only area which caused me any concern was where some previous expert had brazed a couple of joints on the door pillars: brazing is quick and easy but is a terrible fix - you can't weld on top of it & the bronze reduces the strength of the surrounding metal to its own level. I had to cut away the bronzed sections and patch them later.

After plenty of persistence, I really felt like a surgeon when I picked the last welds away & lay the nose on the ground. This proved a great bonus: not only could I de-rust and seal the inner sides of the nose and body, I could fill all the pinholes in the nose and remove all the small dents which had accumulated over the years. That V-profile of the splittie nose has to be one of the prettiest shapes to ever be pressed into sheet

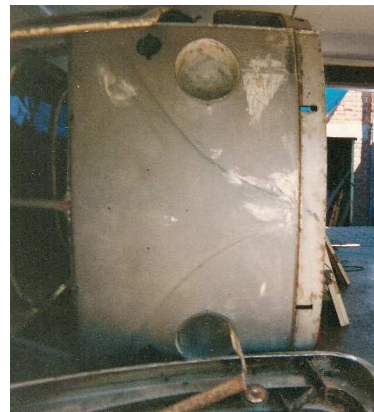
With the nose smoothed, the valence replaced and everything looking clean, in Nov 2001 I tacked the nose back in to position. After months of having the front end open, it was a real joy to see it looking "normal" again. Then out came the grinder and Dremel so I could cut out all the rusty metal from under the van. The grinder is great for big cuts and the Dremel (or a die-grinder) allows you to get in to those tight corners and also to make a much thinner cut. The first real section I tackled was the driver and passenger floor. I had to cut away an area about 30cm long and 20cm wide on each. I used the old sections as templates and cut replacements out of flat sheet. I made up a die out of a block of steel that had about the same profile as the corrugations in the floor and then hand beat the sheets til they had the same pattern in them as the original. Time consuming & laborious. Now that these panels are relatively cheap it hardly seems worth the effort, but at the time it was the best solution for me. Fortunately my dog-legs were pretty sound and all I had to do was cut out a couple of small sections and graft in clean metal.

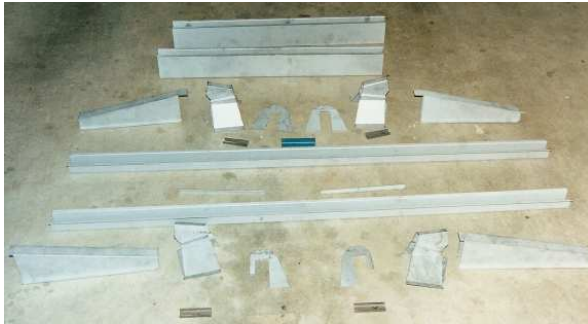
I spent a few hours measuring up the sections I needed and took my drawings to Steven's Sheet Metal who went to work on sheets of zincalume: 11 hours of labour later and, in early 2002, I had a new set of doglegs, cross-members, front valence, side panel, inner and out sills, repair section for the windscreen and cargo doors and a few more odds and sods include a complete 600mm high repair section for the driver's side. Today I would have simply bought all new panels but at the time choice was far more limited and prices quite a bit higher. As I laid out all the new parts on the floor, I started to worry about whether I would be able to get them all on. Was I going to be up to the task?

Through all this I tried to keep myself to working in one area of the car, so I could see myself making progress in one spot before tacking the next. With the box-sections replaced I tackled the passenger side inner and outer sills and the jacking points. I was very happy with how these worked out: they were the most complex piece to measure and bend. Probably 4 hours of the labour was involved in just the jacking points. This was complicated by the fact that they were also cut from 1.2mm sheet!

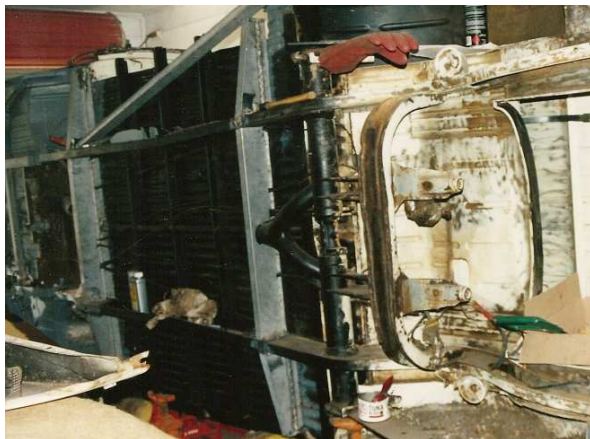
On my list of new panels was a pair of replacement sections for under the windscreen. Before fitting, I carefully cut them to the required length and opened up the holes for the windscreen wipers. The guys at Steven's had done a great job of getting the profile exactly the same as the original section, meaning that as I

tacked them in place, I could see everything was going to line up really well. The nose had taught one important lesson: you can never have enough G-clamps and vice grips.
