1967 Kombi Restoration : Part 3

Paint and panel

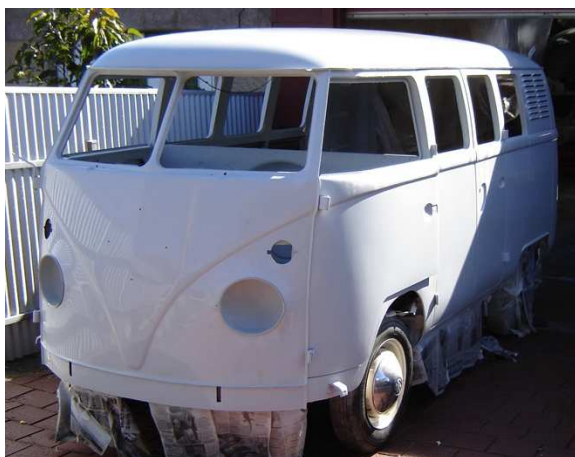
I managed a few other minor jobs during this time. One of these was to attack all the hinges. After 40 years of opening and closing, the hinge pins get worn and the doors flop about on the hinges. To make it worse,

the hinge pins rust in to place and can't be driven out. This meant carefully drilling out the hinge pins and locating oversized replacements. Fortunately they are available (along with correctly sized clearance drill bits) from Motorspares. The cargo door and rear gates hinges all received new pins. The pins on the lower cab door hinges were replaced and the upper hinges made ready for new stainless steel mirror arms.

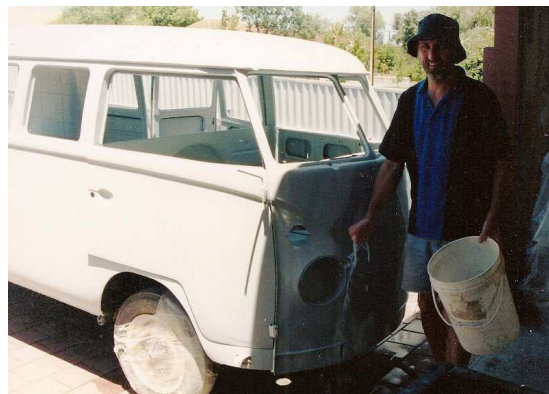
Whether this approach is better – or easier – than the traditional approach of primer then spray putty remains to be seen. Spray putty is certainly a lot easier to sand!

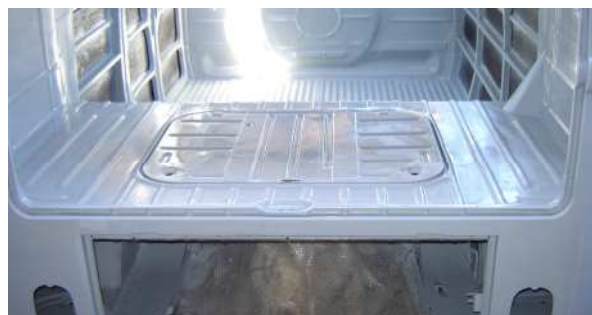
After completing the priming, I had another idea: Bay Window kombis were fitted with an engine inspection hatch which greatly eased access for servicing and repairs, could I fit one to my splittie? Fortunately one of the cars that passed through our shed was a T3 Squareback.

These have the largest of all engine covers - dwarfing the ones found on later bays. This was another of those scary jobs: fancy cutting solid, primed metal! None the less, I persisted and the end result is superb. Looks like it came out of the

factory like that. I even used some spare ute ribs as reinforcing under the front and rear edges.

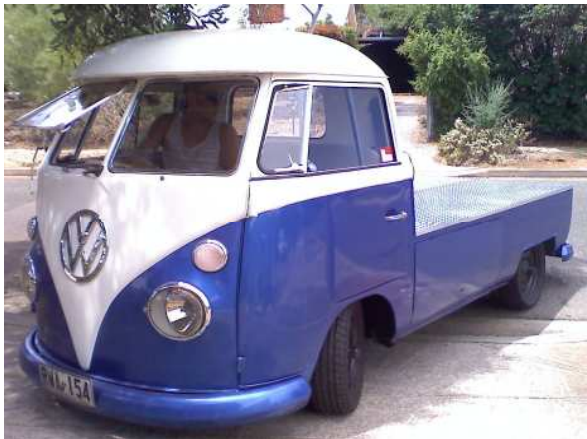
Just as we had done on the Club Kombi, the first layer of two-pack primer was sanded back, only to reveal lots of highs and lows. This necessitated some more judicious tapping, a touch of filler and more sanding. Once all this was done, I hit it with another coat of primer – enabling me to finish off the engine inspection hatch at the same time. Once this second coat of primer was flatted, things ground to a halt again: too many other cars, too much time on the Club Kombi and too little cash.
