1967 Kombi Restoration : Part 2

Metal Work

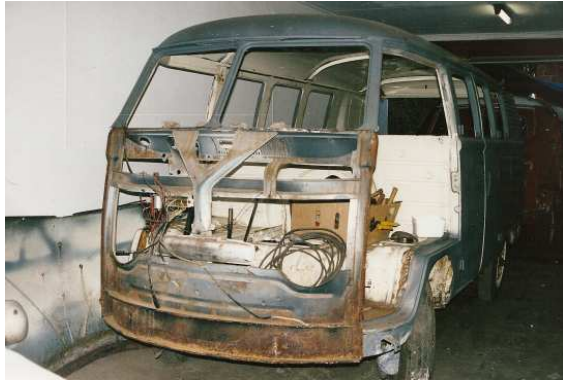
In June 2001, my attention turned to the kombi's nose. With plenty of trepidation I unpicked all the welds around the side and bottom. Then I simply cut across the bottom of the windscreen: because the lower sections had to be replaced I had plenty of room to move and this left me with clean metal at the top of the nose to graft to. Likewise with the valence, as it was being replaced it could simply be cut away. The only area which caused me any concern was where some previous expert had brazed a couple of joints on the door pillars: brazing is quick and easy but is a terrible fix - you can't weld on top of it & the bronze reduces the strength of the surrounding metal to its own level. I had to cut away the bronzed sections and patch them later.
