1967 Kombi Restoration : Part 6

Putting it back together

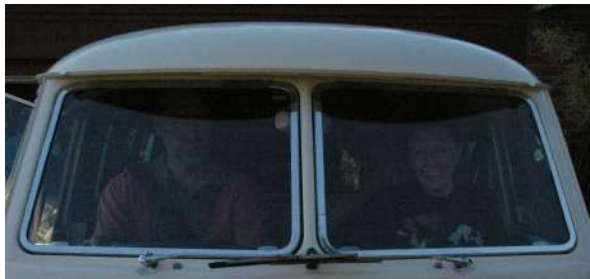
The body was painted, all the electrics and accessories cabled in, glass tinted, motor standing by, complete set of body and glass seals at hand. The time frame was looking feasible.

I spent a few weeks tackling more filler jobs, while leaving the paint a chance to harden up. I cleaned up the fuel tank and hit it with POR fuel tank sealer, prior to fitting it back into the engine bay. This is one task which was made far easier through installation of the engine inspection hatch.

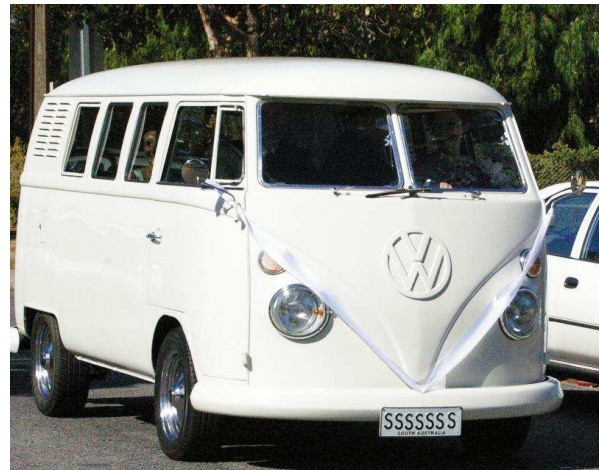
In what seemed no time at all, Easter had arrived. Good Friday was a real milestone: for the first time, I was able to start the car, put in gear and drive it up and down the driveway. What a feeling. Although there were still a few jobs to be done, I was now confident that we would make the wedding. I had to borrow a few parts from Andrew's car: his beautiful, re-trimmed seats; windscreen wipers (the shafts on mine had seized solid and broke when I tried to free them); a few bits of engine tinware and a few sundry bits and pieces. I adjusted the headlights, checked all the other electrics and made sure that the alarm/immobiliser was working properly. The headlights have internal indicators but, because I like the original indicators so much, left the indicators (with new lenses) operational and wired the in-lamp globes to flash when the alarm is set.
